# « JUST THE FACTS »

## Water Intrusion and Premature Coil Failure (UF303)

### Coils and Water Don't Mix!

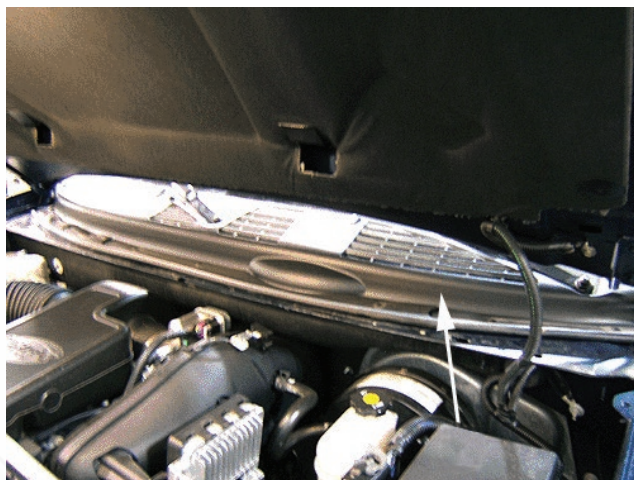
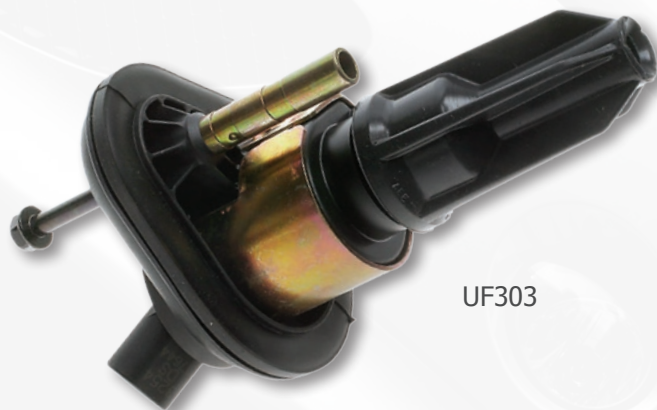
Check for possible DTC codes P0300 through P0306 and inspect the coils and spark plugs. If upon inspection of the coils, a white chalk-like build-up on the inside and/or outside of the spark plug boots is detected, the coils have been damaged and must be replaced—Standard® hi-quality UF303 coils should be installed. It is also advised that the spark plugs be replaced.

Water can seep past the engine cam cover and collect below the coils in the spark plug wells of the cylinder head resulting in a possible misfire. To prevent this condition from reoccurring, the AIP seal must be replaced with a replacement seal that redirects the water away from the engine cam cover.
