Just the Facts

Water Intrusion and Premature Coil Failure (UF303)

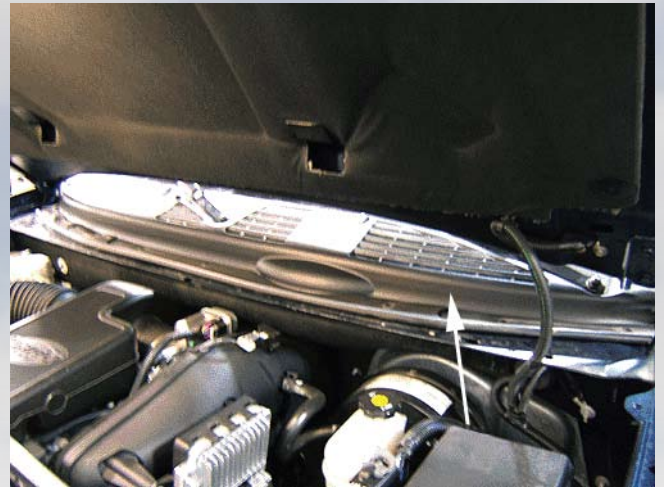
Check for possible DTC codes P0300 through P0306 and inspect the coils and spark plugs. If upon inspection of the coils, a white chalk-like build-up on the inside and/or outside of the spark plug boots is detected, the coils have been damaged and must be replaced—Standard hi-quality UF303 coils should be installed. It is also advised that the spark plugs be replaced.

Water can seep past the engine cam cover and collect below the coils in the spark plug wells of the cylinder head resulting in a possible misfire. To prevent this condition from reoccurring, the AIP seal must be replaced with a replacement seal that redirects the water away from the engine cam cover.
