« JUST THE FACTS »

Don't Get PO'ed with P0401 Codes

Ford P0401 Issues

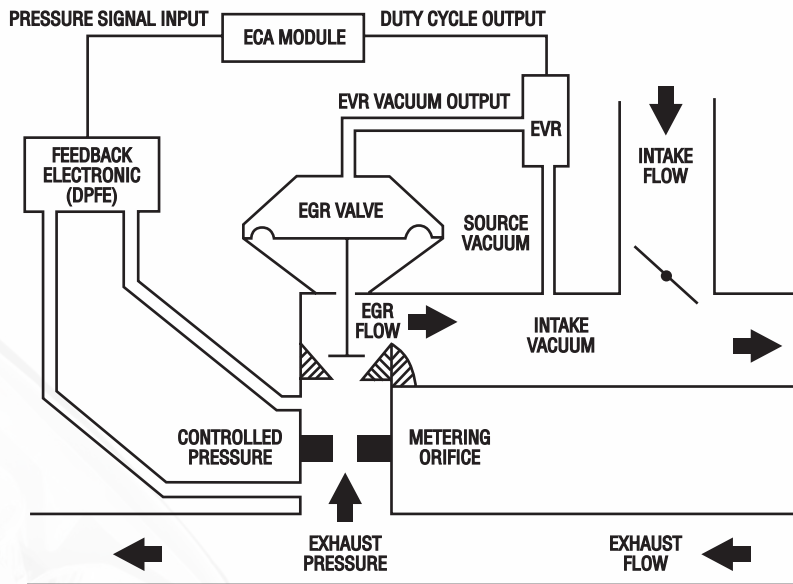
System Diagram

The Ford EGR Pressure Feedback system is known for persistent P0401 EGR low flow code issues. Bear in mind, low flow can be caused by several issues.

The most common issue is the failure of the EGR Pressure Feedback sensor commonly known as the DPFE sensor. If the diaphragm in the sensor becomes weak or the sensor is contaminated with moisture it can fail to supply the computer with the correct reference voltage. When this occurs, the computer increases the vacuum supply to the EGR valve causing the vehicle to run poorly. When the low flow signal is unable to be corrected by the computer's adjustment, then the computer sets a P0401 code for EGR flow.

To prevent a recurrence of the P0401 code, Standard® recommends inspecting and replacing if necessary, the EVR and DPFE hoses when replacing the DPFE sensor. To further guard against a P0401 code, a de-carbonization treatment of the EGR system should be performed.

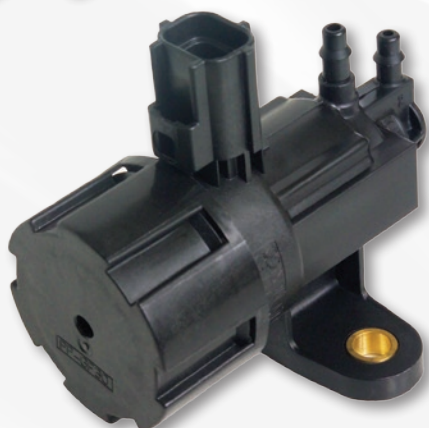
EVR
VS63

The other parts that commonly get overlooked are the EGR Valve Regulator (EVR), which is cataloged as an EGR control solenoid, the DPFE hoses, and carbon build-up inside the EGR system. The EVR is responsible for supplying the proper vacuum to the EGR valve. Any resistance in this control circuit or failure of the EVR can cause a P0401 code. The original DPFE hoses are a special high-temperature hose. These hoses can crack or collapse internally over time due to intense thermal cycling that takes place within the EGR system.
