« JUST THE FACTS »

Water Intrusion and Premature Coil Failure (UF303)

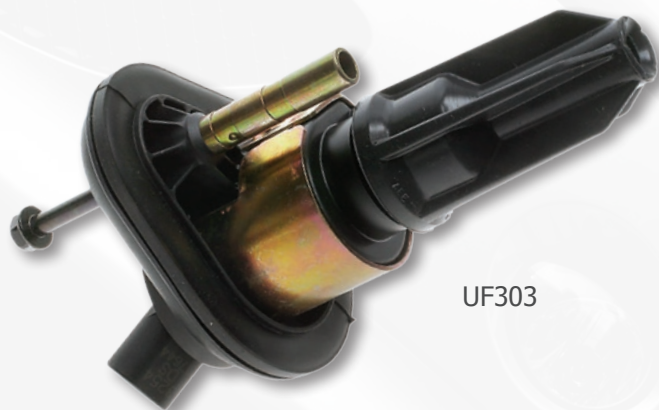
If a customer complains of a rough idle and/or the MIL/SES light flashes on after a rain shower or car wash, this may indicate water intrusion.

Check for possible DTC codes P0300 through P0306 and inspect the coils and spark plugs. If upon inspection of the coils, a white chalk-like build-up on the inside and/or outside of the spark plug boots is detected, the coils have been damaged and must be replaced—Standard® hi-quality UF303 coils should be installed. It is also advised that the spark plugs be replaced.

Water can seep past the engine cam cover and collect below the coils in the spark plug wells of the cylinder head resulting in a possible misfire. To prevent this condition from reoccurring, the AIP seal must be replaced with a replacement seal that redirects the water away from the engine cam cover.
