# « JUST THE FACTS »

## Don't Get PO'ed with P0401 Codes

### Ford P0401 Issues

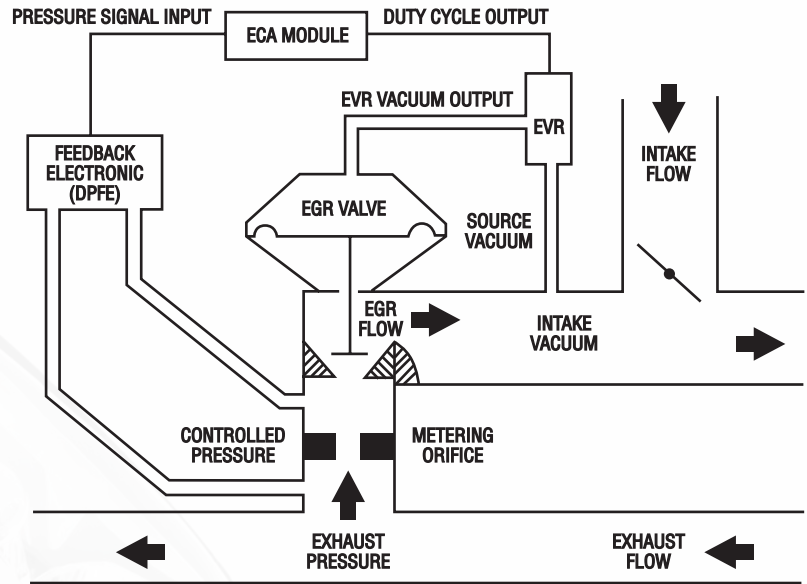
System Diagram

The Ford EGR Pressure Feedback system is known for persistent P0401 EGR low flow code issues. Bear in mind, low flow can be caused by several issues.

The most common issue is the failure of the EGR Pressure Feedback sensor commonly known as the DPFE sensor. If the diaphragm in the sensor becomes weak or the sensor is contaminated with moisture it can fail to supply the computer with the correct reference voltage. When this occurs, the computer increases the vacuum supply to the EGR valve causing the vehicle to run poorly. When the low flow signal is unable to be corrected by the computer's adjustment, then the computer sets a P0401 code for EGR flow.

To prevent a recurrence of the P0401 code, Standard® recommends inspecting and replacing if necessary, the EVR and DPFE hoses when replacing the DPFE sensor. To further guard against a P0401 code, a de-carbonization treatment of the EGR system should be performed.

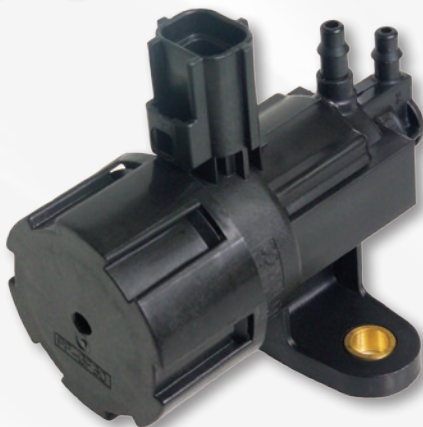
EVR  
VS63

The other parts that commonly get overlooked are the EGR Valve Regulator (EVR), which is cataloged as an EGR control solenoid, the DPFE hoses, and carbon build-up inside the EGR system. The EVR is responsible for supplying the proper vacuum to the EGR valve. Any resistance in this control circuit or failure of the EVR can cause a P0401 code. The original DPFE hoses are a special high-temperature hose. These hoses can crack or collapse internally over time due to intense thermal cycling that takes place within the EGR system.
