Just the Facts

Water Intrusion and Premature Coil Failure (UF303)

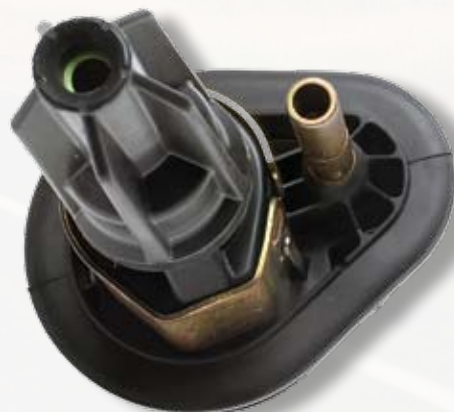
Water can seep past the engine cam cover and collect below the coils in the spark plug wells of the cylinder head resulting in a possible misfire. To prevent this condition from reoccurring, the AIP seal must be replaced with a replacement seal that redirects the water away from the engine cam cover.
