Diesel Fuel Injection Pumps - Remanufactured

Our Multi-Step Process Ensures Quality

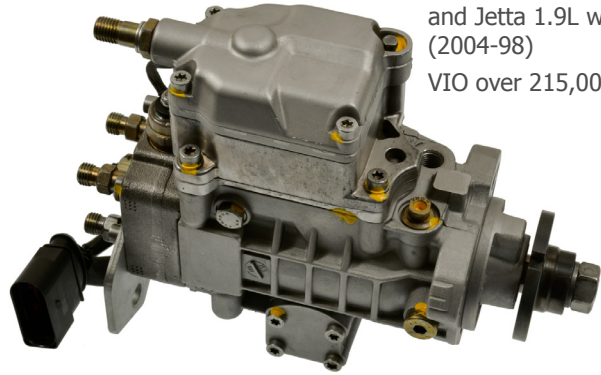
IP49

Volkswagen Beetle, Golf, and Jetta 1.9L w/ AT (2004-98)
VIO over 215,000

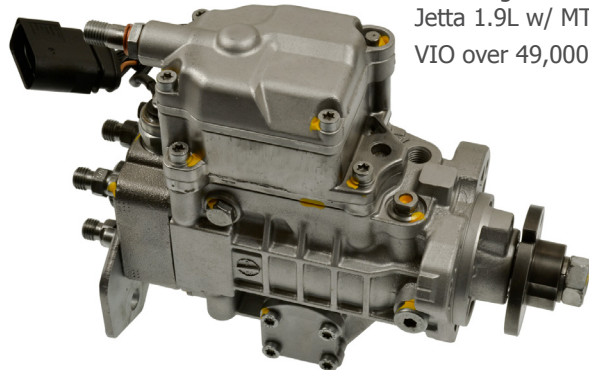
IP50

Volkswagen Beetle, Golf, and Jetta 1.9L w/ MT (2004-98)
VIO over 49,000

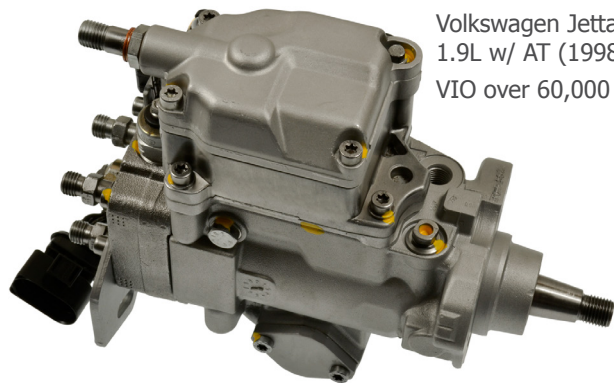
IP51

Volkswagen Jetta and Passat 1.9L w/ AT (1998-96)
VIO over 60,000
