## Anti-lock Brake (ABS) Sensors Testing

### How does the rest of the pack stack up to Standard® ABS Sensors?

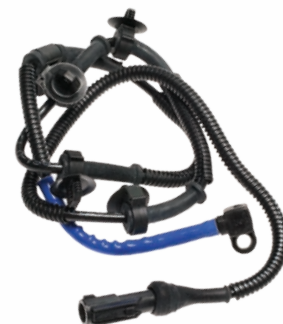
**Standard®:** ABS Sensor# ALS198 (Ford 09-95; ranked in the top 10 sellers) matches OE for output voltage, resistance, trigger wheel gap and all critical fit, form, and function measurables.

**Competition:** 45%-74% lower voltage output when compared to OE leading to potential ABS system failure. Inconsistent winding resistance, electrical inductance and magnetic field orientation resulting in poor sensor performance. Inconsistent gap between sensor tip and trigger wheel leading to potential sensor tip damage.

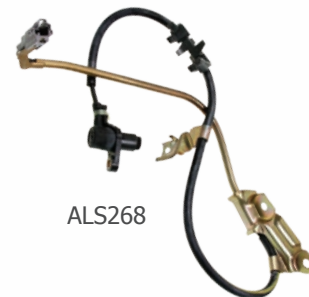
ALS268

**Intermotor®:** ABS Sensor# ALS268, ALS267 (Toyota 96-92; ranked in the top 20 sellers) matches OE for output voltage, resistance, trigger wheel gap and all critical fit, form, and function measurables.

**Competition:** 64%-74% lower voltage output when compared to OE leading to potential ABS system failure. Inconsistent gap between sensor tip and trigger wheel leading to potential sensor tip damage. Does not match OE in electrical inductance and magnetic field orientation resulting in poor performance. Does not include the seal to stop contaminants from entering the functional area of the sensor tip. Metal harness channel does not match the OE shape.
